Manhole Inspection Summary

Manhole # S290__040MH

Insp Date: **4/13/09 12:20 PM**

Location Address: **1203 SCOTT ST**

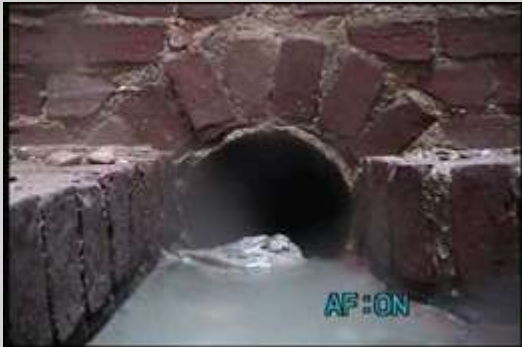
12 O'Clock Outflow

Pipe Height: **8.4** (in.) Rod and Bar (Angled)
Pipe Material: **Clay** ☐ Pipe Lined
Invert Depth: **10.64** (ft.) Flow Characteristics: **Slow**
Deposits: ☒ None ☐ Mud ☐ Sludge ☐ Debris ☐ Grease
Silt Depth: **0** (in.) Deposits Extent:
Infiltration: **None** Pipe Seal Cond: **Sound**

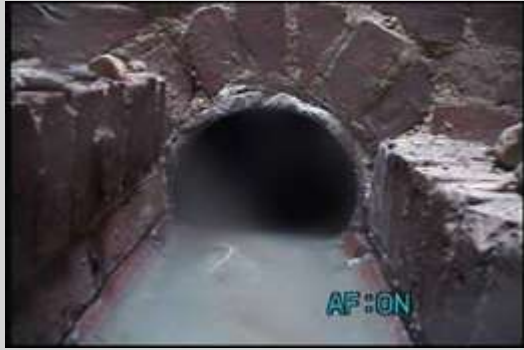
6 O'Clock Inflow

Pipe Height: **8.4** (in.) Rod and Bar (Angled)

Infiltration: **None** Pipe Seal Cond: **Sound**
